Non-Shielding Pipeline Coatings

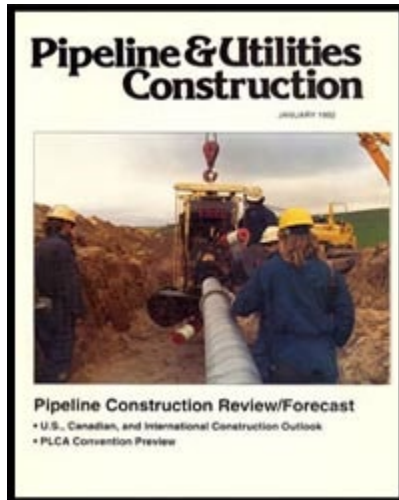
RD-6® has a 25 year field history, with thousands of installations worldwide, including this one shown on the January 1992 cover of Pipeline and Utilities Construction magazine.

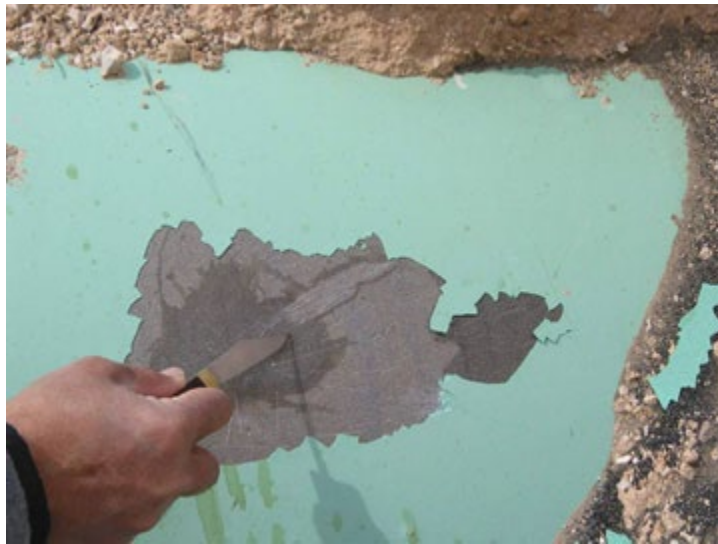
This disbonded FBE had no corrosion underneath. The pH of the water under the blister was elevated (made more alkaline) as the result of the CP currents being able to reach underneath the disbondment.

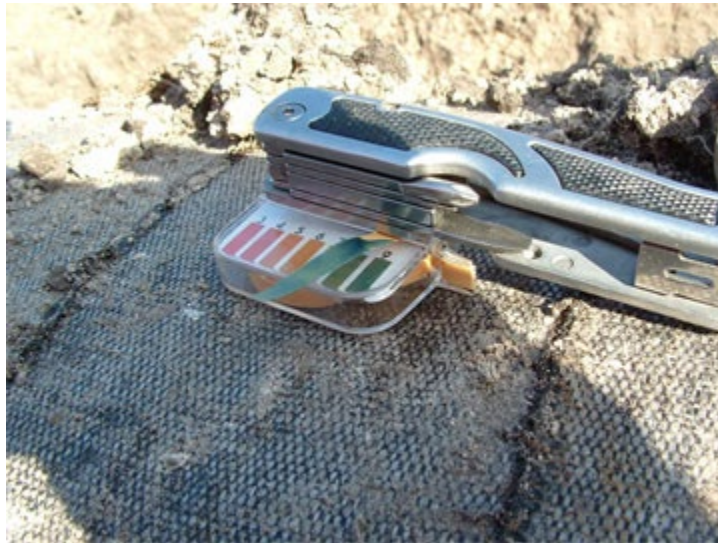
Water underneath a disbonded area of this improperly applied RD-6® had a pH of 9-10, as compared to water under nearby disbonded coal tar coating, which has a pH of 5-6. The CP current had increased the alkalinity of the water under the RD-6® to a level which does not support corrosion.
