CRH18 SECTION @ CRM MEMBRANE REPAIR PATCH LESS THAN 2"

Polyguard Products, Inc.
P.O. Box 755 - Ennis, TX 75120
Phone: 214-515-5000
Web Site - www.polyguard.com

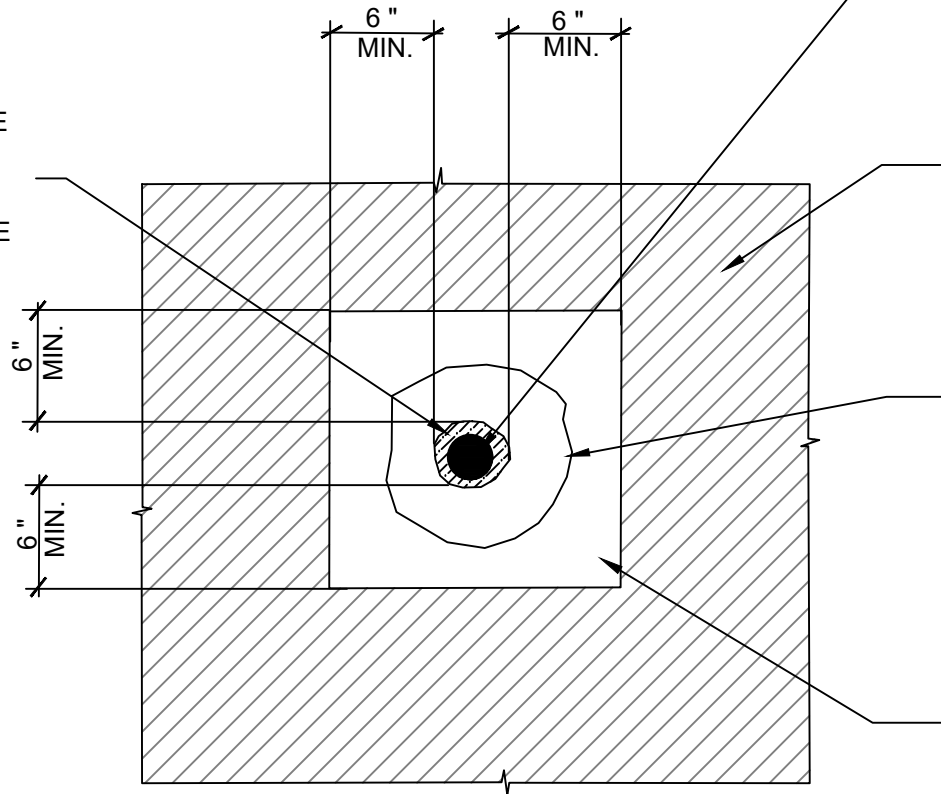
SPREAD A 1" MINIMUM LAYER OF POLYGUARD CR LIQUID MEMBRANE TO THE BACKSIDE OF THE POLYGUARD CRM MEMBRANE AND INTO HOLE COMPLETELY FILLING HOLE - ENSURE THAT ALL MEMBRANE EDGES ARE COATED COMPLETELY

REPAIR AREA - USE CORRECT POLYGUARD DETAIL FOR SIZE OF DAMAGE

POLYGUARD CRM MEMBRANE FABRIC PREPARED WITH POLYGUARD CR SEALANT APPLIED TO A CLEANED AREA 6" BEYOND THE DAMAGE IN ALL DIRECTIONS AT A RATE OF 50 - 75 SF/GAL

APPLY 60 MILS OF POLYGUARD CR LIQUID MEMBRANE 3" PAST OUTER EDGE OF HOLE ONTO FABRIC OF POLYGUARD CRM MEMBRANE PREPARED WITH POLYGUARD CR SEALANT AT A RATE OF 50 - 75 SF/GAL

POLYGUARD FABRIC TAPE APPLIED OVER POLYGUARD CR LIQUID MEMBRANE AND FABRIC OF POLYGUARDL CRM MEMBRANE PREPARED WITH POLYGUARD CR SEALANT AT A RATE OF 50 - 75 SF/GAL
