Sump Pump Performance Javits Center Green Roof Houston Country Club

The Houston Country Club now has a new underground parking garage that has room for more than 400 vehicles. This 170,000 sq. ft. facility is protected from the wet Houston environment on the top, bottom and all sides.

COUNTRY CLUB
 Innovative Waterproofing by Phil Funkhauser

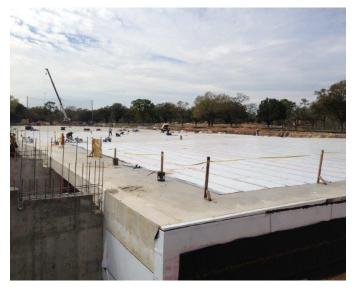
*Under construction photo of the garage lid with the Polyguard 650 installed. Ramp tunnel to the left of the photo.*

The post-tensioned garage lid was the last concrete to be poured and was sloped to allow water runoff around the perimeter. It was waterproofed with Polyguard's 650 Membrane System and 1/4" Asphaltic Hardboard. In addition, Western Waterproofing installed Poly Flow 18H drainage composite to the perimeter vertical walls.

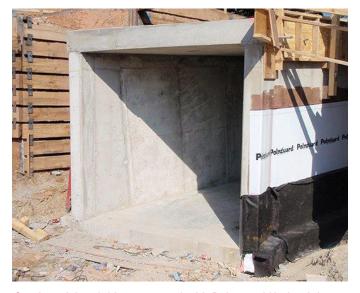
Section of the clubhouse tunnel with Polyguard Underslab beneath the slab and Polyguard 650 with Poly Flow 15P surrounding all sides. The Situra Flamline expansion joint connected the tunnel sections.

tunnels connecting the parking area to the clubhouse and other social venues at the club. These areas were surrounded with Polyguard waterproofing in the same fashion as the garage box with the addition of expansion joint systems from Situra, Inc. that successfully connected the garage to the tunnel and the tunnel to the elevator room for the clubhouse.

These expansion joint systems were compatible with the Polyguard Waterproofing Systems used, and helped to complete the envelope of protection required.
